International Journal of Human Sciences Research

STRUCTURAL DEFORMATION ANALYSIS BY LANDSLIDE IN REINA DEL CISNE SECTOR - PACCHA USING LIDAR SCANS AND CLOUDCOMPARE SOFTWARE

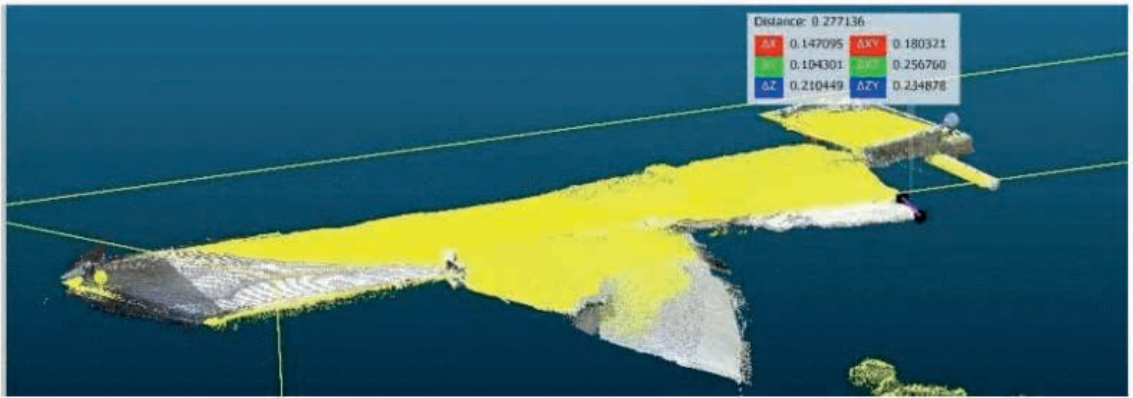
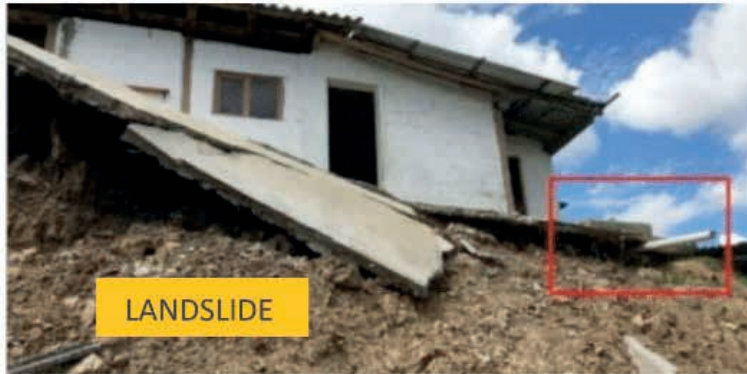
The alignment of the two massive point clouds from the scans performed in the months of May and June 2017, has revealed that the landslide has moved significantly during this period of time, as it has significantly affected structures that are close to it, which can be seen in Figures 3, 4 and 5. Unlike structures not so close to it, where the movement is much less, as shown in Figures 6 and 7. Figure 8 shows the location of the profiles made with respect to the sliding mass and Figures 9, 10 and 11 show these profiles in May, June and the superposition between them. In the three profiles, significant ground displacements can be seen, where it can be appreciated that the house tends to follow the direction of the landslide, which we can verify with the results cited above. In the profile of Figure 9 it can be noted that the landslide has tilted the house to the left side, creating a certain convexity in its structure, which has its maximum point between the abscissa of 13.00 m to 13.5 m, which causes the structure of the house to suffer from internal cracking, which will worsen as the sliding mass increases.

Figure 3. (Top) Slab near the landslide, in yellow: May scan and in RGB: June scan, (bottom) slab in field.

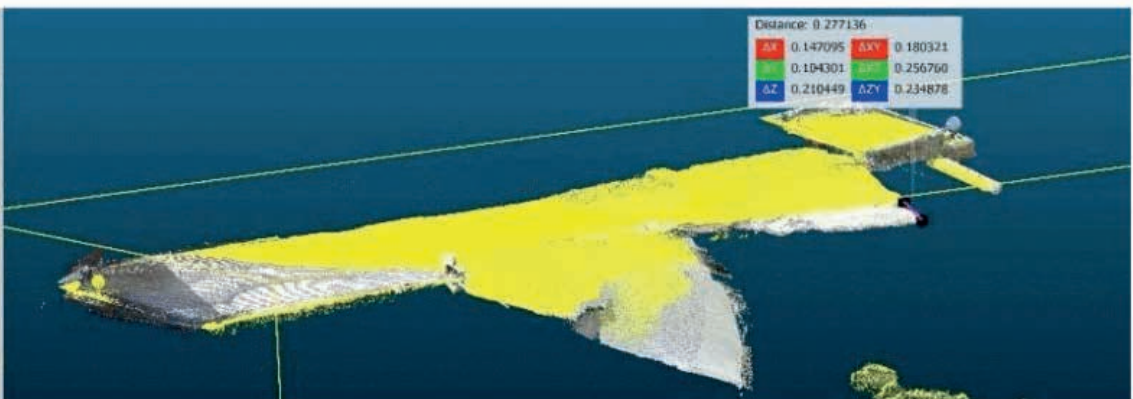
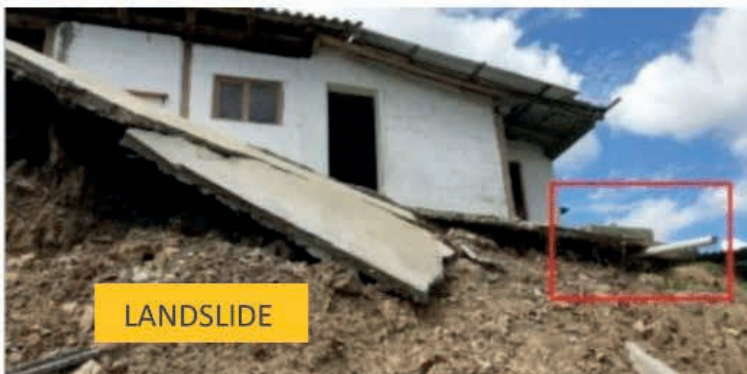
Figure 4. (Left) Slab near the landslide, in yellow: May scan and in RGB: June scan, (right) slab in field.

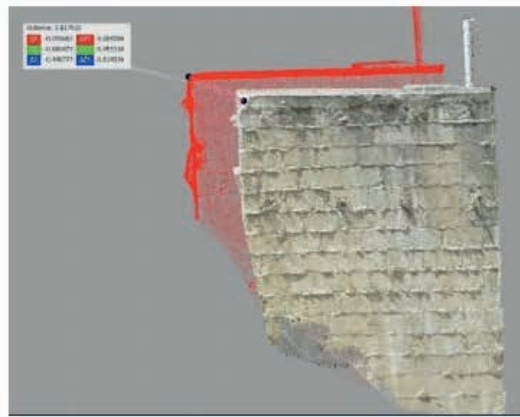
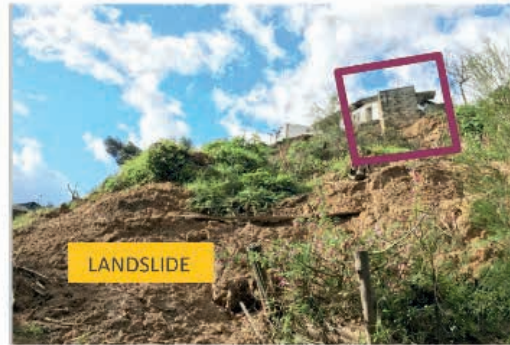
Figure 5. (Top) Tank near the landslide, in red: May scan and in RGB: June scan, (bottom) tank in the field.

problems that this kind of landslide presents, which are: escarpments (Figure 8, above), cracks, alterations at the foot of the landslide, vegetation removal (Figure 5, below), fissures, tree movements and landslide activity (Parkhurst, 2000).

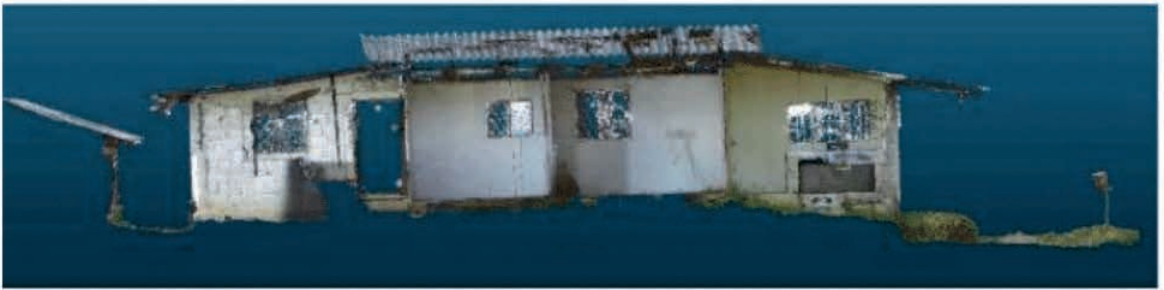
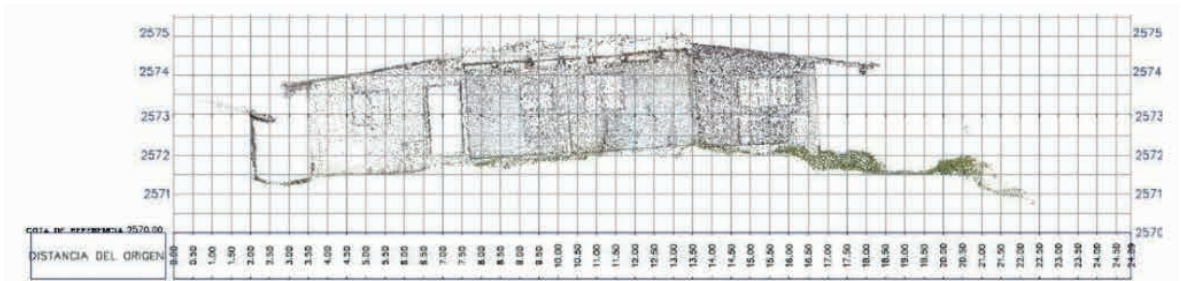
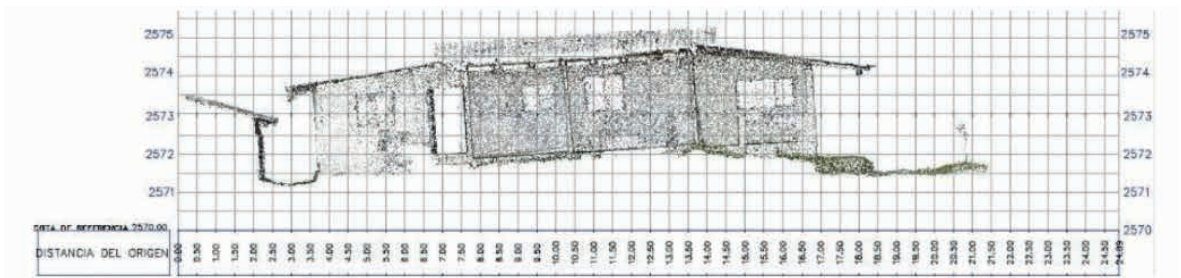
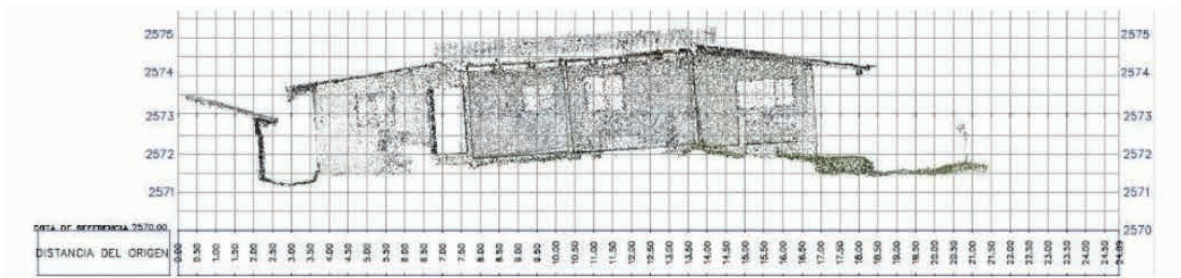
Figure 9. Profile 1 (longitudinal) in May, June and comparison of both.

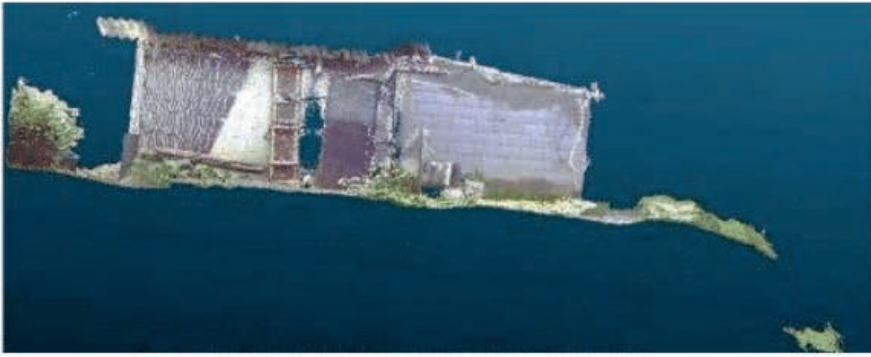
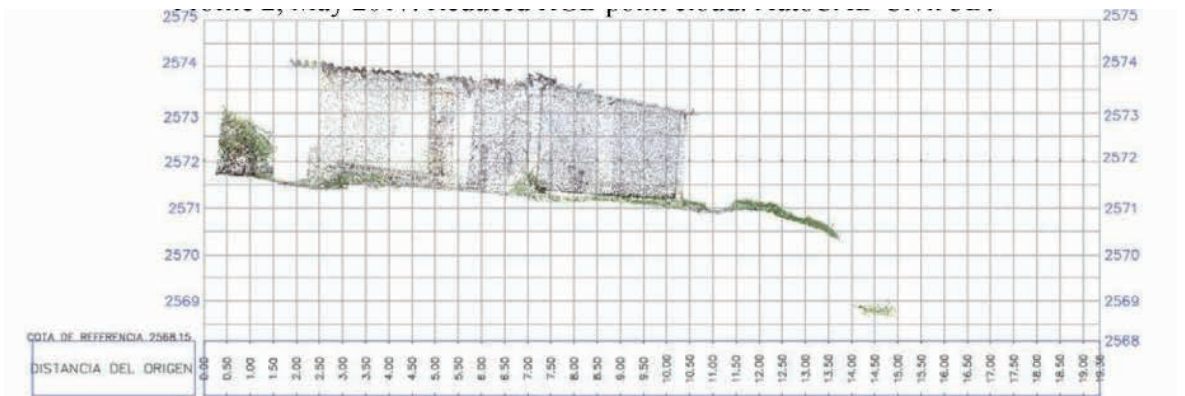
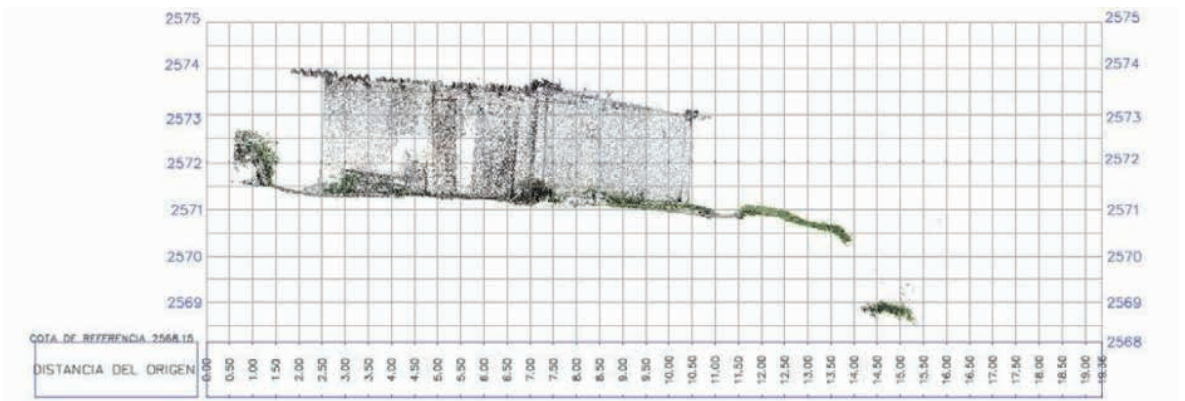
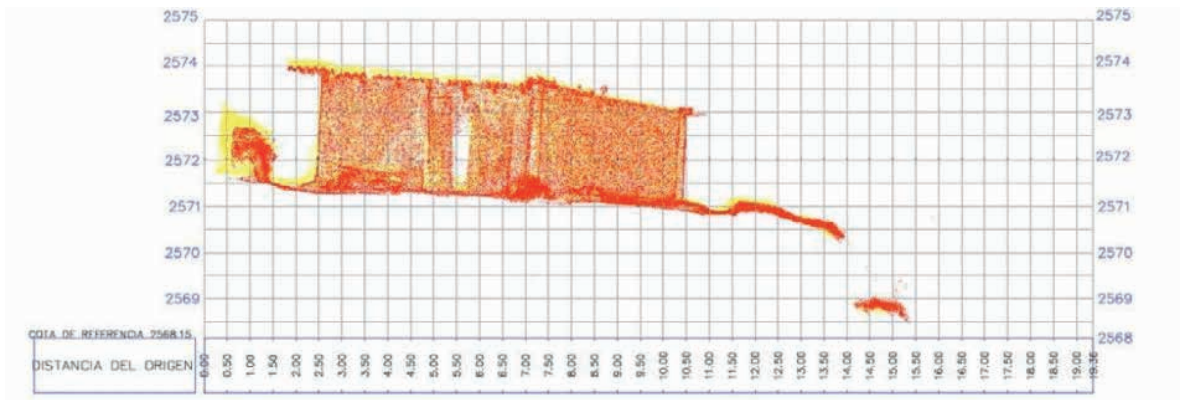
On the other hand, the profile in Figure 10 shows the inclination that the house now presents, since it has lost support due to the landslide. The house has lost support due to the landslide that has removed material, so that the house has tended to follow the direction of the landslide.

Figure 10. Profile 2 (cross-sectional) in May, June and comparison of both.
Profile 3, May 2017. 100% RGB point cloud. CloudCompare

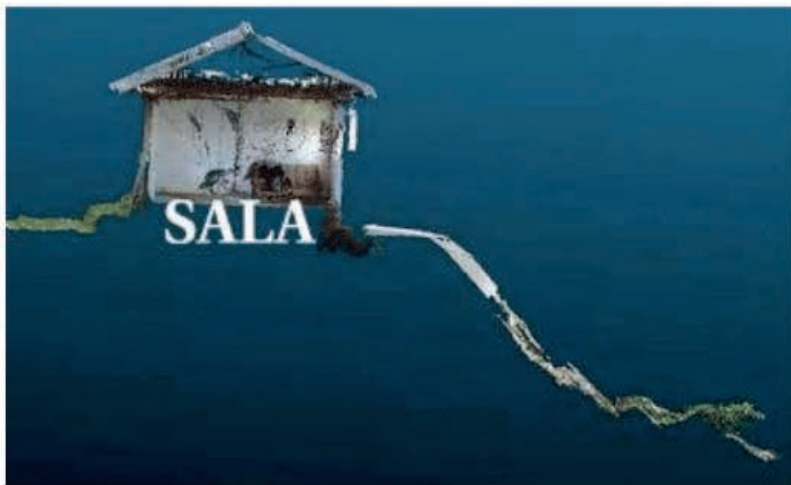
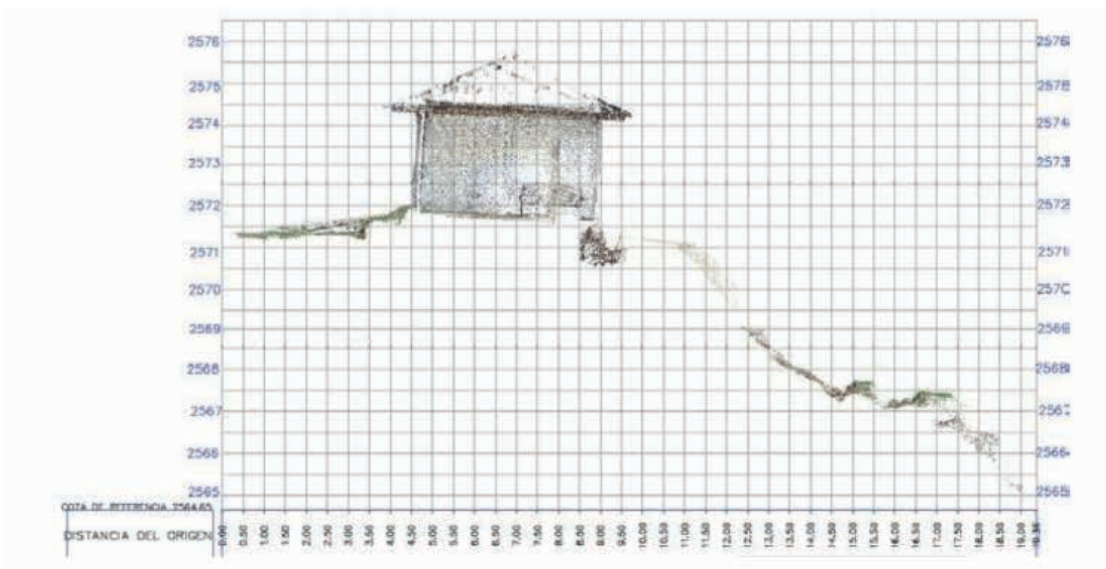
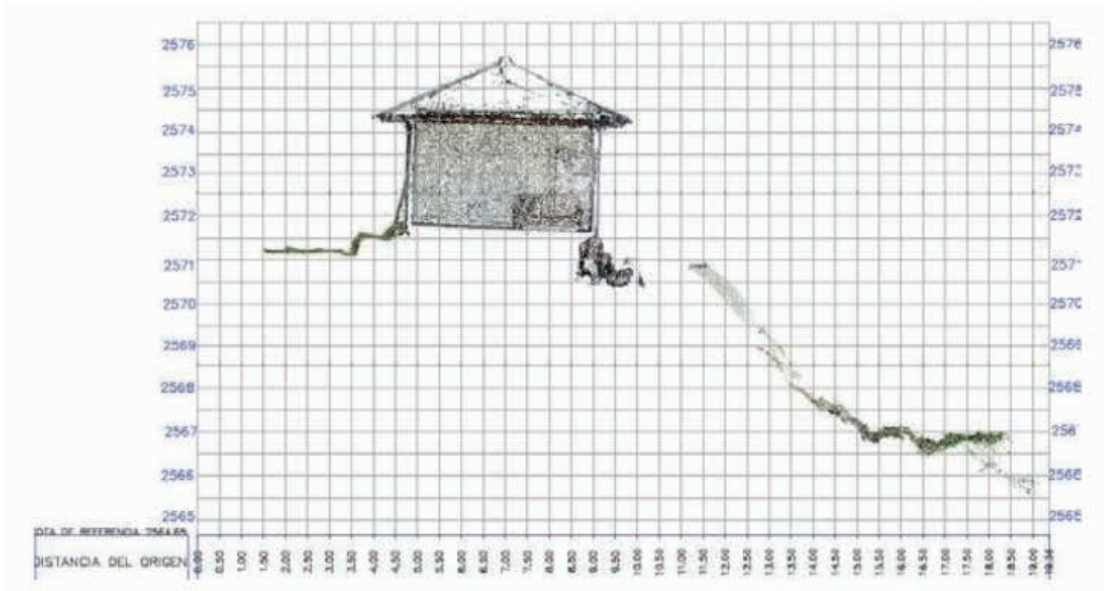
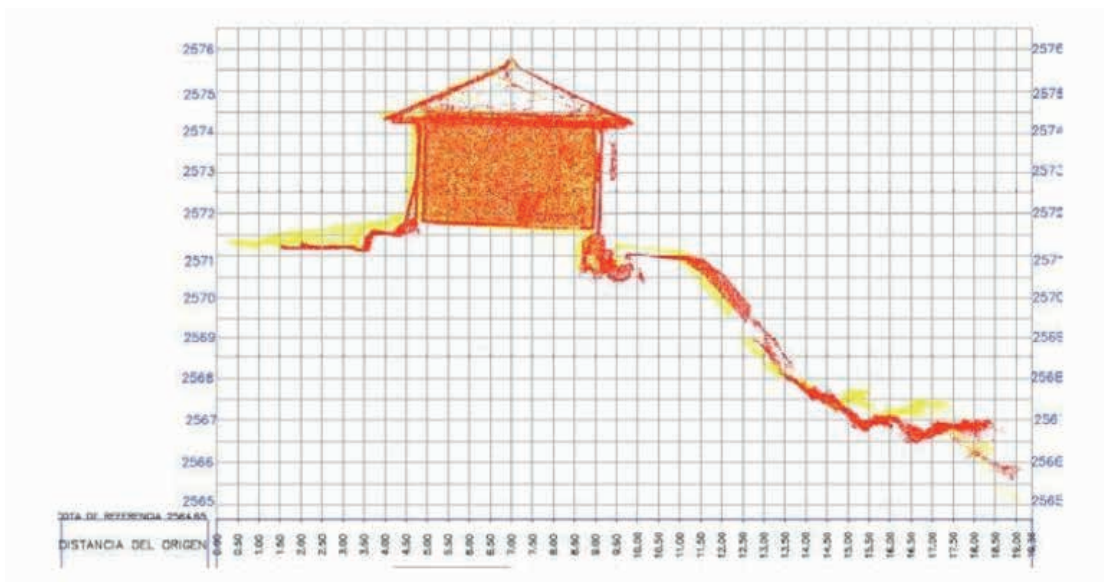
In the same way, the profile in Figure 11

shows how the house is leaning towards the direction of the landslide, causing the house to lean in the direction of the landslide. This can be interpreted by comparing one scan with another, where the slab together with the ground tends to move more and more, in the same way it can be seen in the house.

Figure 11. Profile 2 (cross-sectional) in May, June and comparison of both.
