INFLUENCE OF GROUNDWATER DEPLETION ON A GEOTECHNICAL STRUCTURE

Ian Henrique Pires

Augusto Romanini

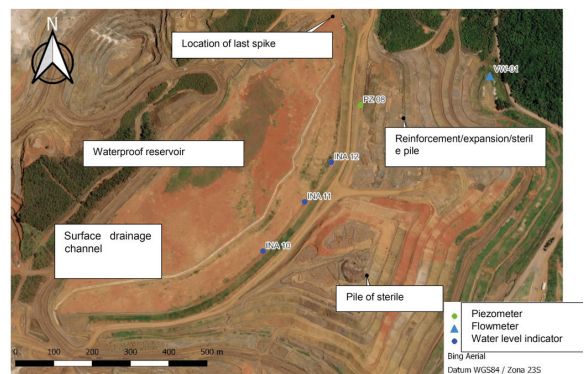
Figure 2 – Instrumentation map

The influence of decommissioning and decharacterization on the depletion of phreatic water in the massif is also observed in analyzes and graphic interpretations of instruments, such as: water level indicators, piezometer and bottom drain meter. Figure 2 shows the location of the instrumentation analyzed and the main components of the structure:

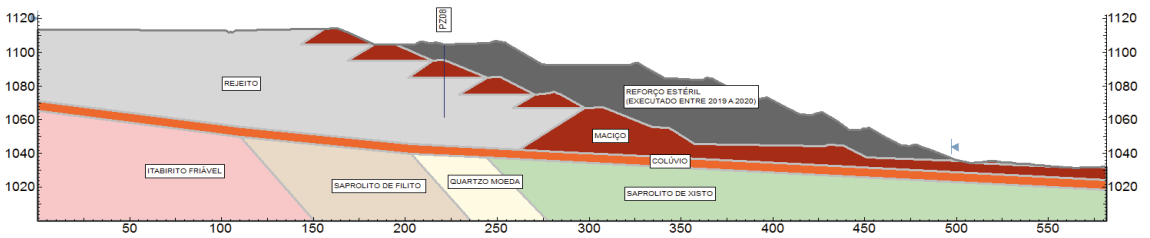
Figure 1 - Critical section of the Dam

Percolation analyzes were conducted using the Steady State FEA Finite Element Method, using Slide2 Software, developed by the Canadian company RocScience. The program is used to model water flow and the distribution of pore pressures in porous media through numerical analysis. The model section will be the most critical of the bus,

represented by Figure 1, without water table.

The boundary conditions used for the numerical model were the piezometric level (PZ08) in the most critical section and the unit flow rate of the bottom drain (VW01). We also chose to use the boundary condition, in the extreme left tailings in relation to PZ08, Zero Pressure in both scenarios at elevation 1090m.

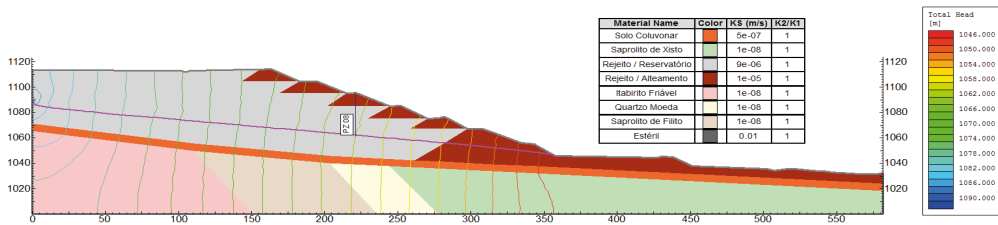
Figure 3 – Flow analysis (post decommissioning scenario)

The flow networks obtained are presented in Figures 3 and 4 for the post-decommissioning and post-decharacterization scenarios, respectively:

The flow networks obtained with the boundary conditions used make it possible to visualize the reduction of the water table in the main section of the structure. In the analysis of the post-characterized scenario, the equipotential lines indicate a reduction in the potential load from PZ08 onwards. Therefore, the horizontality of the water table is observed, which indicates that the hydraulic gradient is close to 0 and, consequently, minimizes the occurrence of piping in the massif.

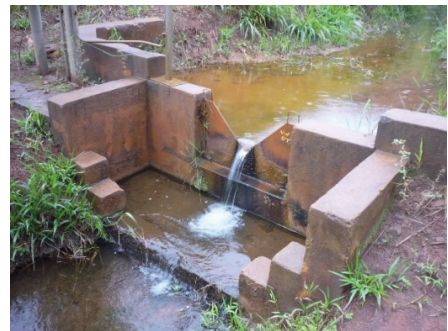
Figure 6 - Flow Meter

Figures 6 and 7 for the years 2018 and 2022, respectively, indicate the decrease in the flow meter flow:

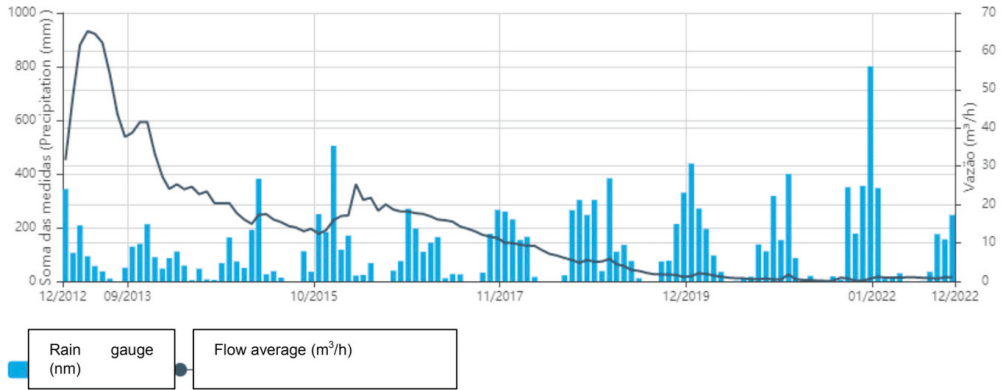
Figure 5 – Graph of the sum of monthly rainfall and average bottom drain flow
 Source: Authors (2023)

The flow meter will be analyzed using the average monthly readings associated with the sum of monthly rainfall. That said, Figure 5 presents the temporal analysis graph of both quantities, covering the period from 2012 to 2022.

From the graph, one can observe the increase in the bottom drain flow, in 2012 to 2013, shortly after the last raising of the dam, reaching flow peaks in the order of $60 \text{ m}^3/\text{h}$. Then, a decline was noted until the end of 2015 with a reduction rate of approximately 82%.

At the beginning of 2016, the high rainfall during the period contributed to the increase in the average, reaching values in the range of 25 to $30 \text{ m}^3/\text{h}$. From this period until the end of 2019, the flow reduction rate was 95%. The post-decommissioning period is characterized by a sharp reduction in the bottom drain flow, with little or no influence from rainfall and with values below $1 \text{ m}^3/\text{h}$,

In the post-decharacterization period, the graph shows flow behavior without major variations, as already observed in previous periods. During this period, the average flow is $1.48 \text{ m}^3/\text{h}$.

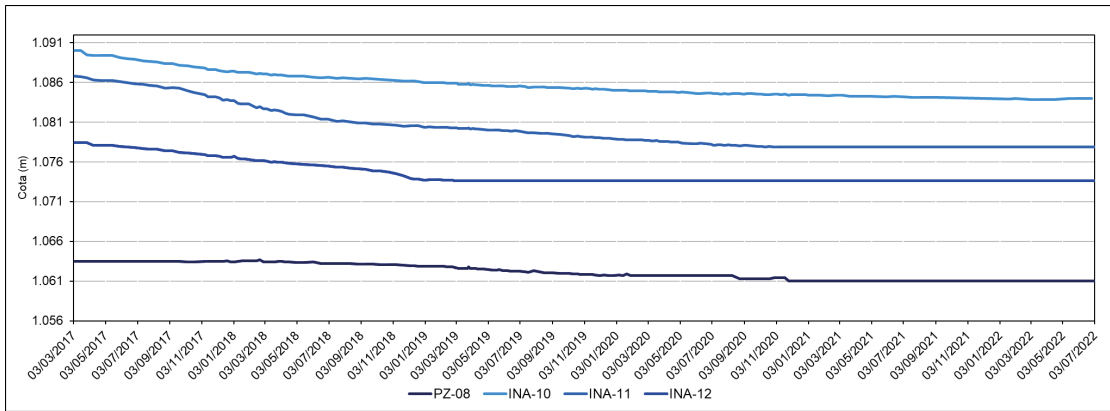
Figure 8 – Time analysis graph
 Source: Authors (2023)

The same panorama observed in the behavior of the bottom drain flow meter is noted in the water level and piezometer indicators. Therefore, Figure 8 presents graphs of instrument readings from different sections of the structure and referring to the period after decommissioning until decharacterization.

In line with the bottom drain flow, the water table of the instrumentation installed in the dam mass decreased after decommissioning. The last instrument readings were considered “dry”, that is, they did not show a water column.

Given the waste disposal system before decommissioning, it is possible to observe that INA 12 depleted first due to its proximity to the spiking point, then INA 11 and, subsequently, INA 10, this being located in the region closest to the lake in relation to the other instruments analyzed.

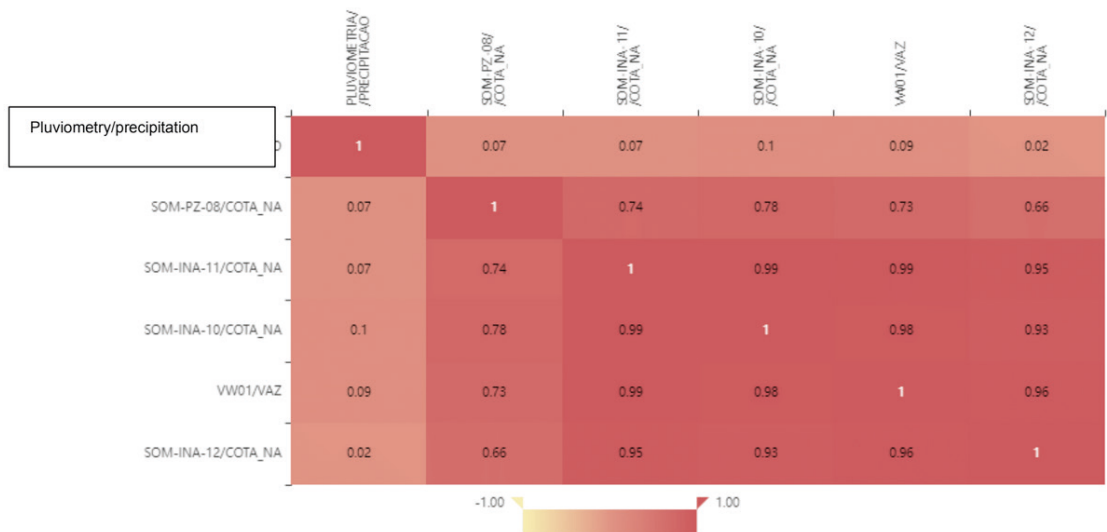
Figure 9 - Correlation Matrix
 Source: Authors (2023) h

Additionally, Figure 9 presents the correlation matrix of the instruments analyzed in the period from 2017 to 2022.

In this context, it is observed that for the period analyzed, a moderate to strong correlation is obtained between the instruments, that is, there are similarities between the phreatic line and the bottom drain flow in the decreasing behavior.

When analyzing rainfall with the other instruments in the correlation matrix, it is stated that precipitation does not immediately influence the reading of the instruments. The correlation obtained is classified as weak.
