# Journal of Engineering Research

STRUCTURAL EVALUATION OF "UNIVERSITY OF VERACRUZ RECTORY OFFICE BUILDING" IN XALAPA, VERACRUZ, MEXICO

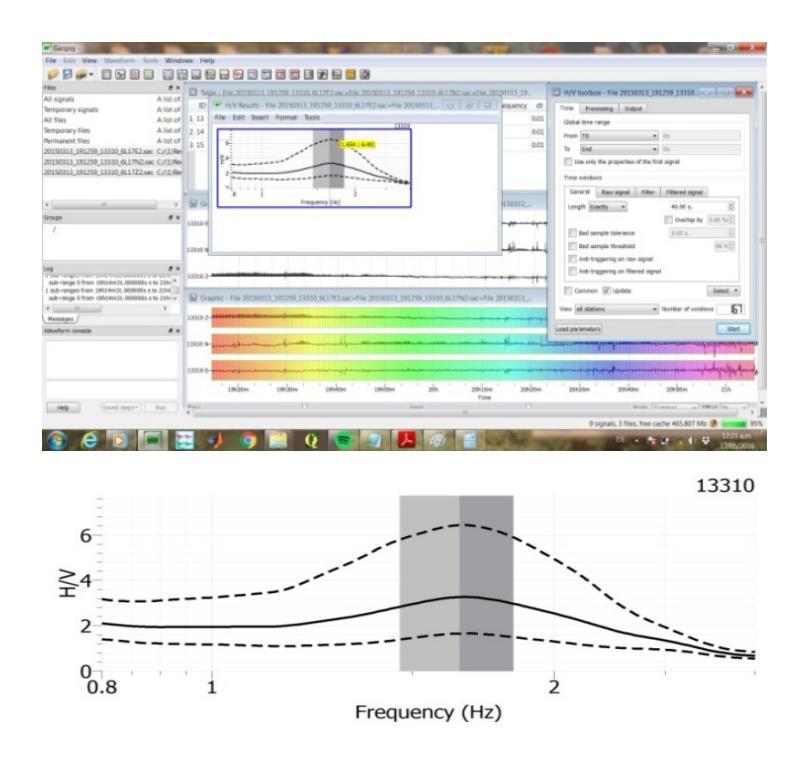
Figure 7. Application of H/V to the soil using GEOPSY and the resulting spectral quotient, F = 1.65, T = 0.6, A = 2.5.

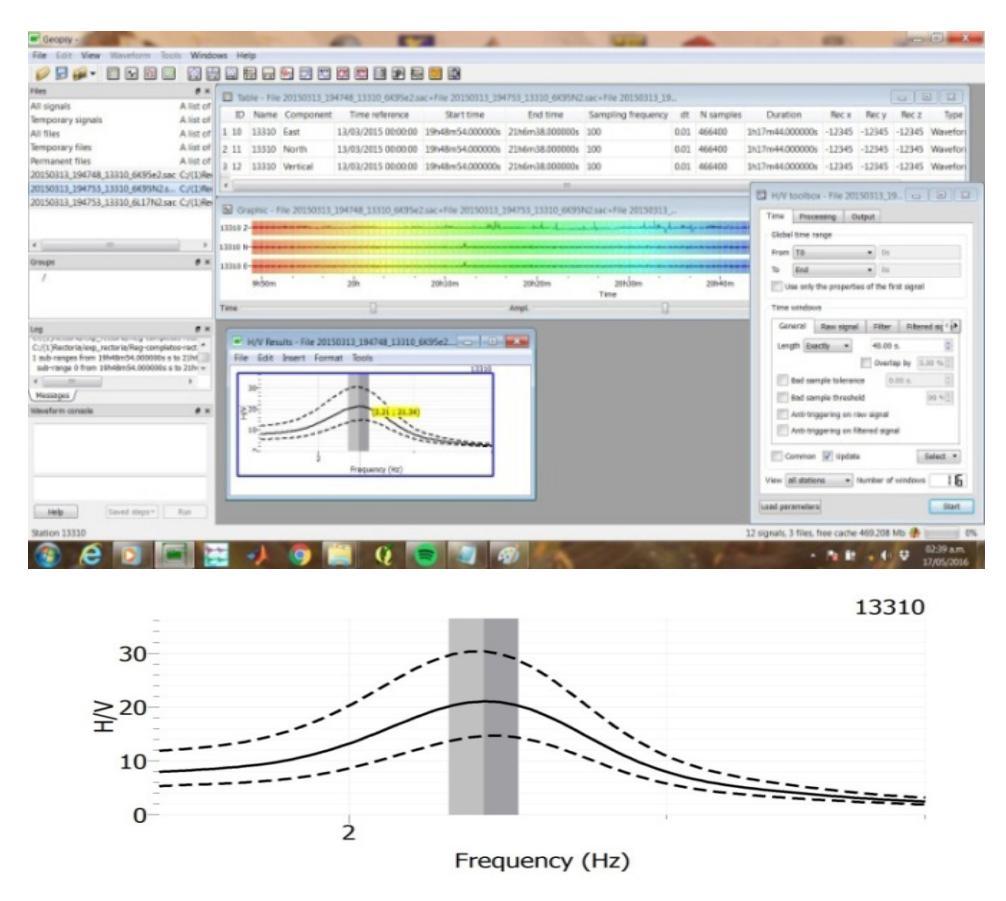
For the equipment placed in the center of the last level in the north-center component (n-c) we obtained:

Figure 8. Standard technique application using GEOPSY (H/V) and the resulting quotient, (n-c) F = 2.21, T = .45, A = 23

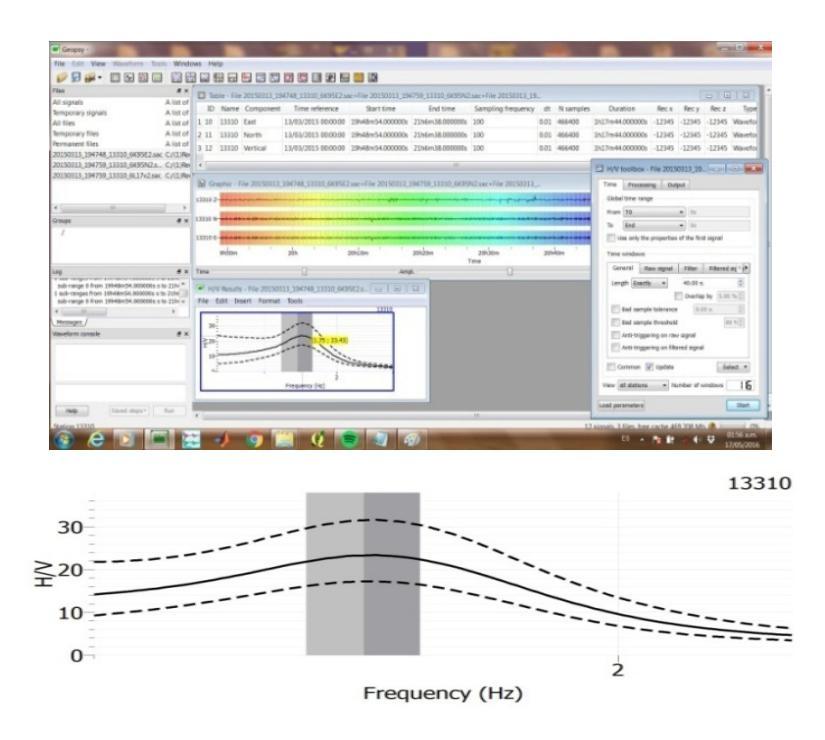
For the equipment placed in the center of the last level in the east-center component (e-c) we obtained:

Figure 9. Standard technique application using (H/V) of GEOPSY and the resulting quotient,(e-c) F = 1.75, T = .57, A = 23

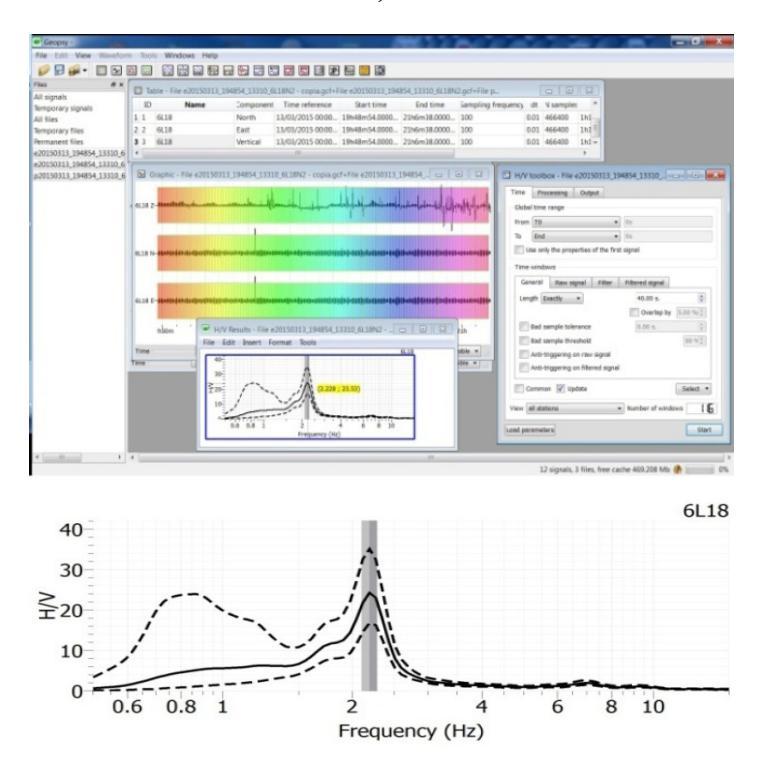
For the team placed in the corner of the last level in the north component we obtained:

Figure 10.Standard technique application using GEOPSY (H/V) and the resulting quotient, (n-corner) F = 2.23,T = .45, A = 23

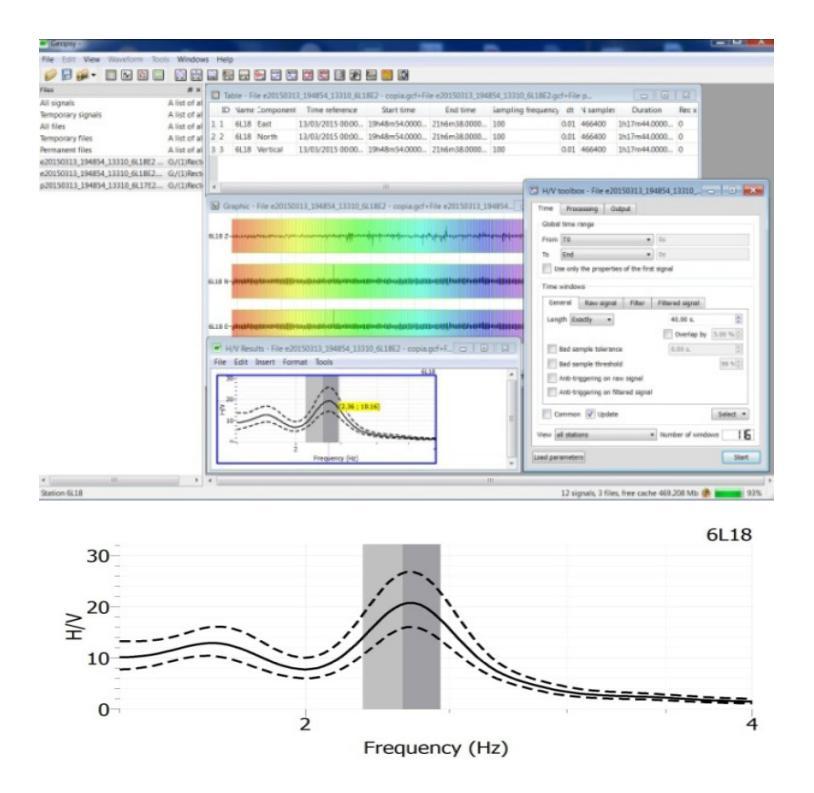
For the equipment placed in the corner of the last level in the component this we obtained:

Figure 11. Standard technique application using GEOPSY (H/V) and the resulting quotient, (e-corner) F = 2.36, T = .42, A = 20

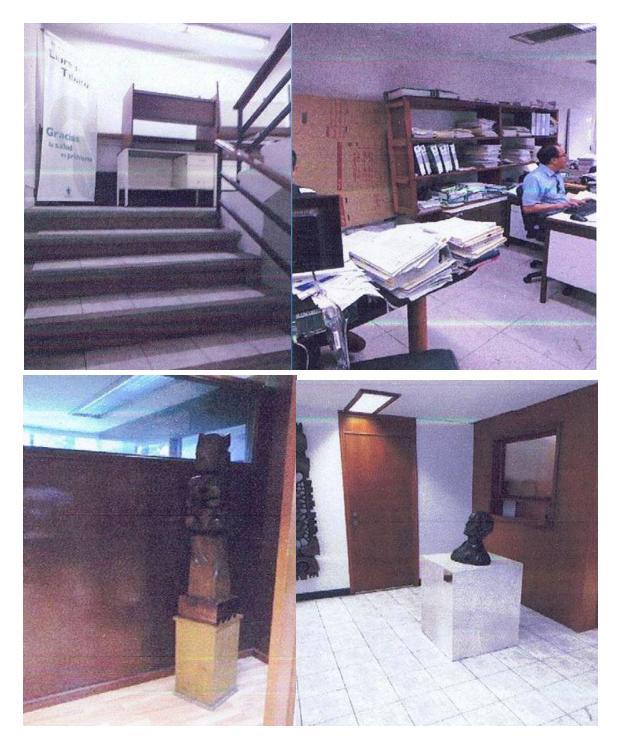
Basement 1: Desks obstruct the emergency exit. In addition, there are some file cabinets in bad condition that obstruct the passage of the emergency exit. We also located gates that are not embedded in the structure

Basement 2: In this area, we found file cabinets and shelves of poor quality, which can overturn. In addition, there are cubicles with glass shutters, which are not embedded in the structure and have a chance of falling. On the part of illumination fixtures, we found lamps without protection, which can fall on the workers.

Access plant: In the access floor, we found a small refrigerator placed on top of afile cabinet, which we consider to be at risk of

falling in the event of an earthquake.

Second Level: On the second level, we found offices that obstruct the exit. In addition to archivists in poor condition. In the cubicles, we found gypsum board walls that are not embedded in the structure.

Third Level (President's office): A bust and a sculpture placed in this area were found, which are not fixed and can be easily detached.

Fourth Level: In the fourth level, the greatest danger we identified were two large book shelves that we consider are not properly fixed and can fall in case of earthquake.

Fifth Level: In the fifth level, we found an archives area, with 24 file cabinets, which represent an excessive weight for the floor slab, which, besides we consider are not properly fixed and have the possibility of falling in case of earthquake. In Figure 12 we show some problems with the contents.

Figure 12. Some examples of problems with the contents of the building, such as partial obstruction of corridors and stairs, bad shelves and some ornate objects that may fall.

Regarding the contents we found that there are partially blocked exits with office furniture in poor condition or that is unused, as well as, that the panels of the divisions of the office cubicles have large crystals that are not embedded in the ceiling, which represents a danger to the occupants of this area in case of a strong earthquake. Also, we found sculpture murals whose fixing to the walls must be verified because they are only supported in the floor and some points on the wall without some limitation in its movements.

It is recommended to unblock the exits, stairs and corridors as well as fasten panels, and ornaments on walls and floors, discard furniture in poor condition, do not place heavy equipment on furniture not resistant, as well as the possibility of creating an alternate emergency exit, and make further studies to see the possibility of stiffening the short direction of the building to prevent that the periods of soil and structure coincide.

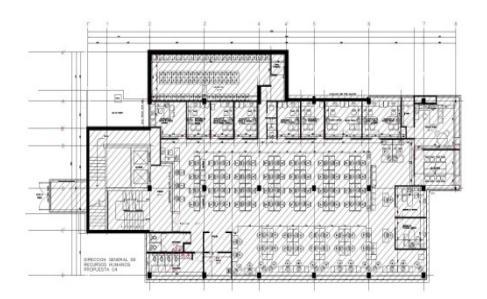
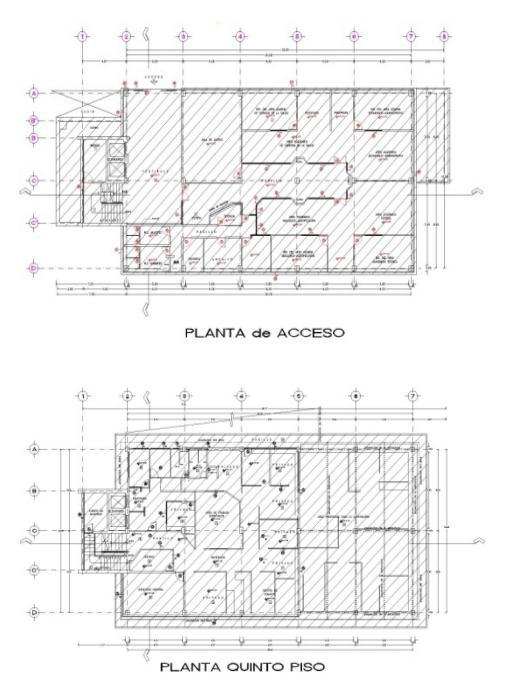
The building has a regular shape both in plan and elevation (Figure 13), which is favorable for its behavior in the event of an earthquake. The values of the dominant periods for the horizontal components are: for the longitudinal (N) of 0.45 sec and for the transversal (E) of 0.6 seconds. If we observe that the band of the dominant period of the soil is 0.6 seconds, it means that the building is vibrating in the transverse direction at the same period as the floor, which represents a severe problem. With this, the building is expected to undergo dynamic amplification due to a possible resonance effect with the floor.

Figure 13. Plants of the President's office building from left to right from the basement to upper mezzanines where plant regularity is observed.

From the results, we can conclude that the building is deployed in an area with a site effect that amplifies the seismic waves. In addition, the period of the cross-section of the building is the same as that of the ground which represents a problem because of the possibility that during an earthquake the building could resonate with the ground.
