International Journal of Human Sciences Research

STRUCTURAL DEFORMATION ANALYSIS BY LANDSLIDE IN REINA DEL CISNE SECTOR - PACCHA USING LIDAR SCANS AND CLOUDCOMPARE SOFTWARE

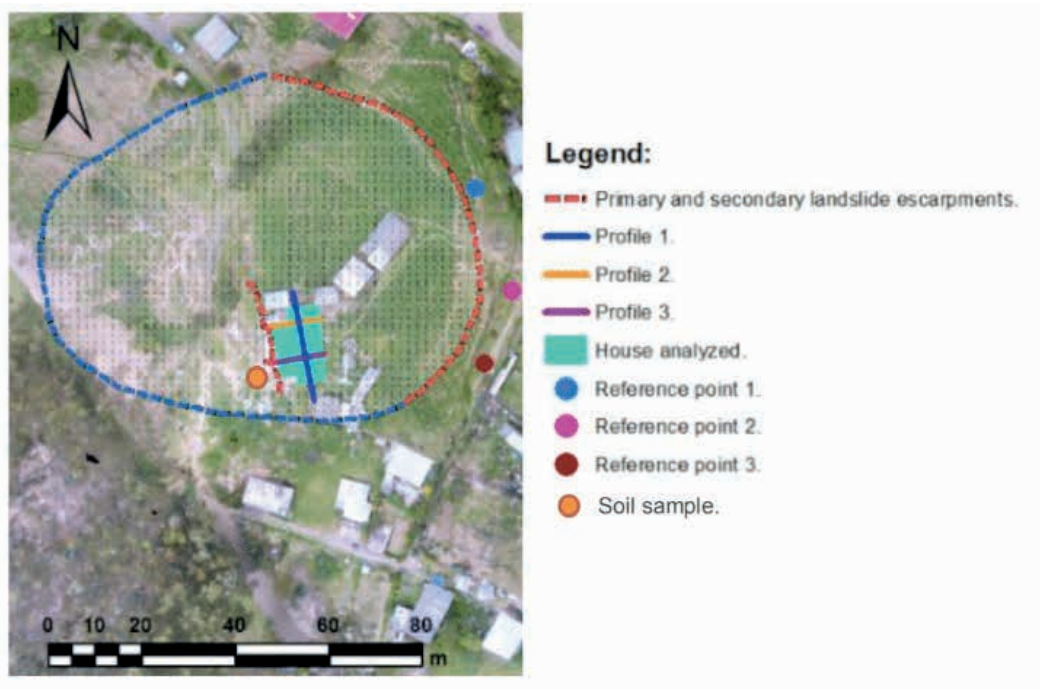
The geotechnical laboratory tests have provided the following results: The soil located in one of the secondary escarpments of the landslide (Figure 1), is residual, called SM Silty sand according to the SUCS classification, which has a natural humidity of 24%. The soil has an expansion percentage: 0.025% which is given a very low degree of expansion. Also, the soil has a swelling pressure of 14.27KPa.

Figure 1. Study area (Cuenca – Ecuador) with information about the landslide and distribution of the profiles studied.

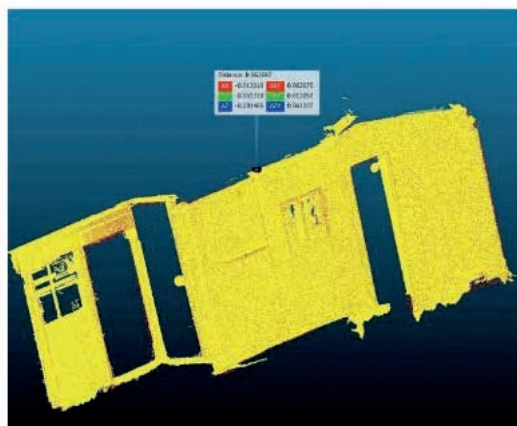
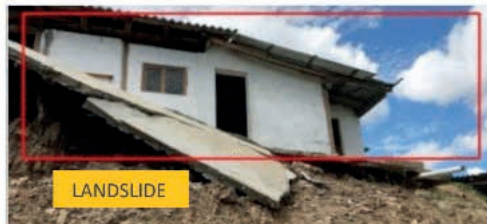
Figure 6. (Top) Wall slightly away from the slide, in red: May scan and in yellow: June scan, (bottom) wall in field.

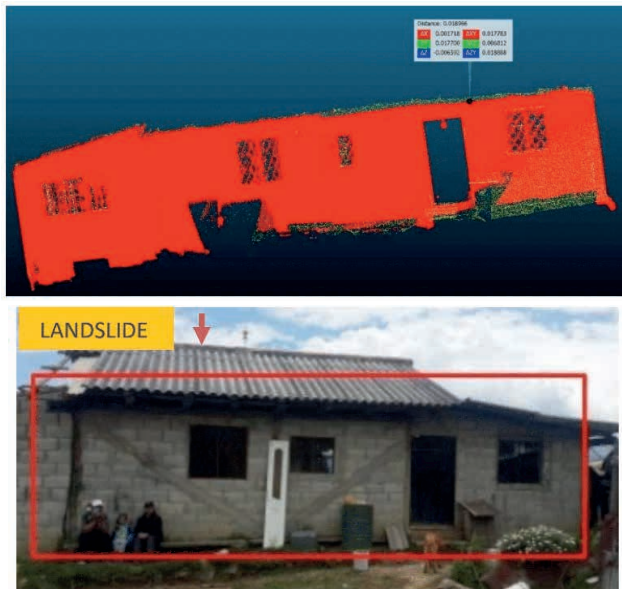
Figure 7. (Top) Wall away from the landslide, in red: May scan and in yellow: June scan, (bottom) wall in the field.

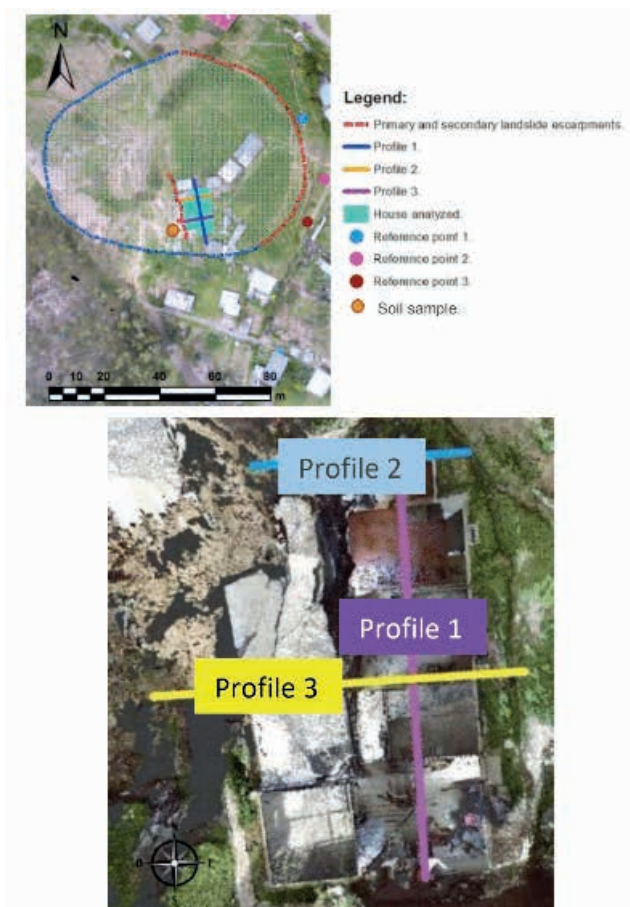
Figure 8. (Top) Longitudinal (1) and transverse (2 and 3) profiles in general plane of the scanned slip area, (bottom) selection of profiles in CloudCompare software.

problems that this kind of landslide presents, which are: escarpments (Figure 8, above), cracks, alterations at the foot of the landslide, vegetation removal (Figure 5, below), fissures, tree movements and landslide activity (Parkhurst, 2000).
